DEPARTMENT OF TRANSPORTATION

Quality Assurance and Source Inspection

Contract #: 04-0120F4Cty: SF/ALA Rte: 80 PM: 13.2/13.9File #: 69.28**WELDING INSPECTION REPORT****Resident Engineer:** Pursell, Gary**Address:** 333 Burma Road**City:** Oakland, CA 94607**Report No:** WIR-004571**Date Inspected:** 10-Nov-2008**Project Name:** SAS Superstructure**OSM Arrival Time:** 630**Prime Contractor:** American Bridge/Fluor Enterprises, a JV**OSM Departure Time:** 1530**Contractor:** Zhenhua Port Machinery Company, Ltd (ZPMC), Changxing Island **Location:** Shanghai, China**CWI Name:** Sun Wei**CWI Present:** Yes No**Inspected CWI report:** Yes No N/A**Rod Oven in Use:** Yes No N/A**Electrode to specification:** Yes No N/A**Weld Procedures Followed:** Yes No N/A**Qualified Welders:** Yes No N/A**Verified Joint Fit-up:** Yes No N/A**Approved Drawings:** Yes No N/A**Approved WPS:** Yes No N/A**Delayed / Cancelled:** Yes No N/A**Bridge No:** 34-0006**Component:** Tower & OBG**Summary of Items Observed:**

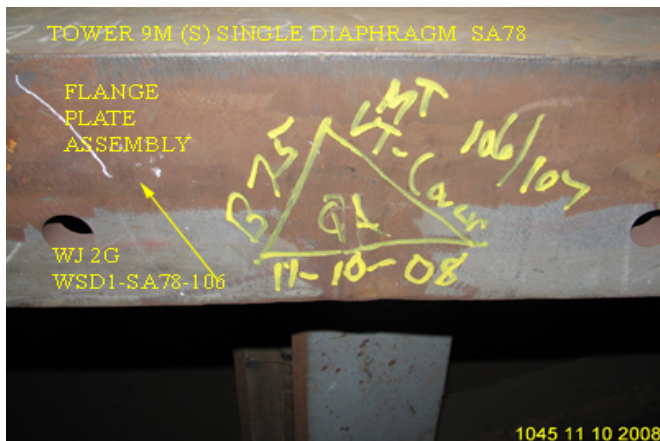
The QA Inspector verified that a final Visual (VT) and MT QC Inspection and QA verifications on the cover pass of the fillet welds on 9M (S) Single Diaphragm SA20, attaching the Flange Plate Assembly to the diaphragm and the fillet welds attaching I-Beams and angle to the diaphragm. The QA Inspector randomly observed ABF Representative Zhanh Hui Pong attach Green Tag 001543 to the part. The attached photograph provides additional detail.
